**PHASE 1 INSPECTION REPORT  
NATIONAL DAM SAFETY INSPECTION**

HERMIT HOLLOW DAM  
FRANKLIN COUNTY, MISSOURI  
MISSOURI INVENTORY NO. 31054

PHASE I INSPECTION REPORT  
NATIONAL DAM SAFETY PROGRAM

Name of Dam:	Hermit Hollow Dam
State Located:	Missouri
County Located:	Franklin
Stream:	Lartto Creek
Date of Inspection:	May 7, 1979

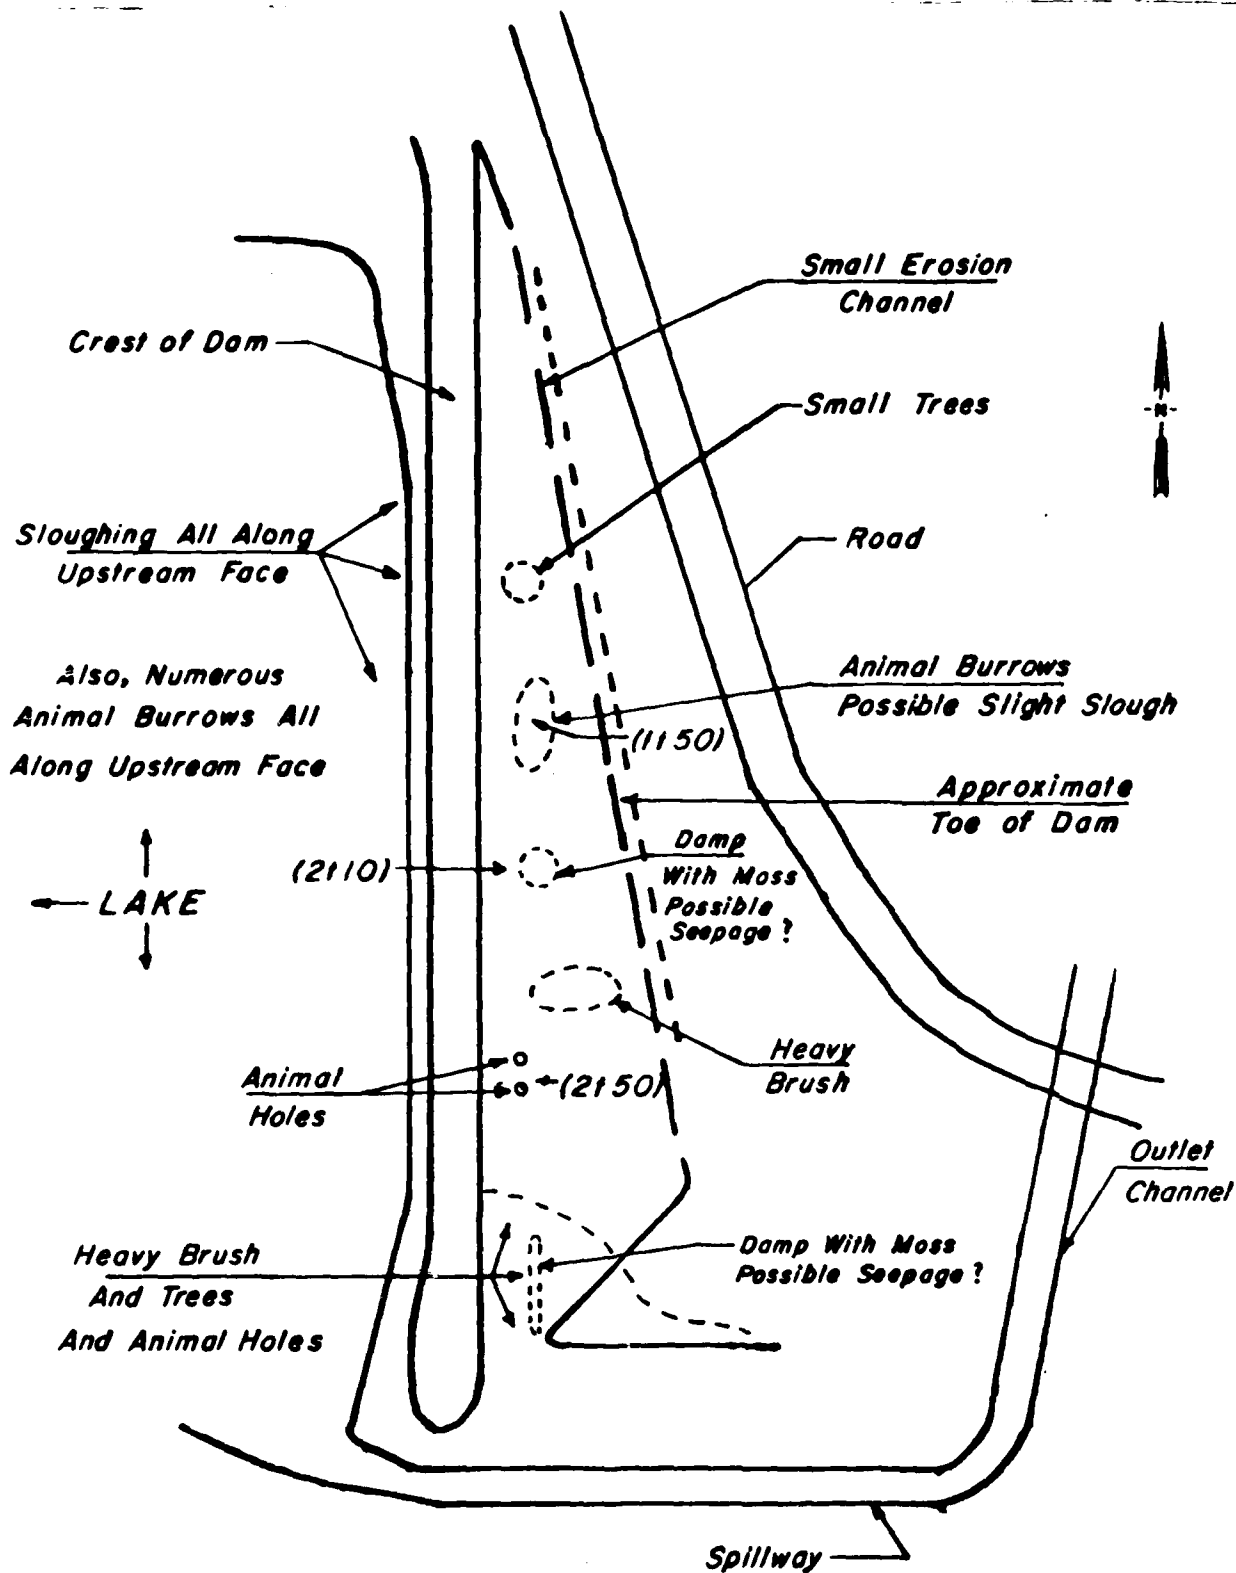
The downstream face was fairly free of heavy vegetation, except for a few localized areas as indicated on sheet 4 of Appendix A. Animal holes were also noted, two of which were fairly large (Station 2+50 and 2+75 - holes 2 ft diameter and 3 ft deep). One 15 ft area at approximate station 1+50 had a considerable number of small animal holes and was disturbed to the extent that it appeared as if it could have been a slight slough. The area was not wet at the time of inspection.

No obvious seepage was noted except for two areas (see sheet 4 of Appendix A) which were damp and growing moss. The downstream face of the dam was fairly free of erosion.

- (4) Animal holes should be repaired on both faces of the dam.
- (5) Trees and brush, as indicated in those areas as shown on sheet 4 of Appendix A, should be removed. This should be done under the guidance of a professional engineer experienced in the design and construction of dams. Indiscriminate clearing methods could jeopardize the safety of the dam.
